**Rationale for Recommended Rejection of the
Vitzhum Gulch Rehabilitation Site as one of the 44
Record of Decision Channel Rehabilitation Sites
Implemented by the
Trinity River Restoration Program**

Hoopa Valley Tribe Fisheries Department

December 17, 2007

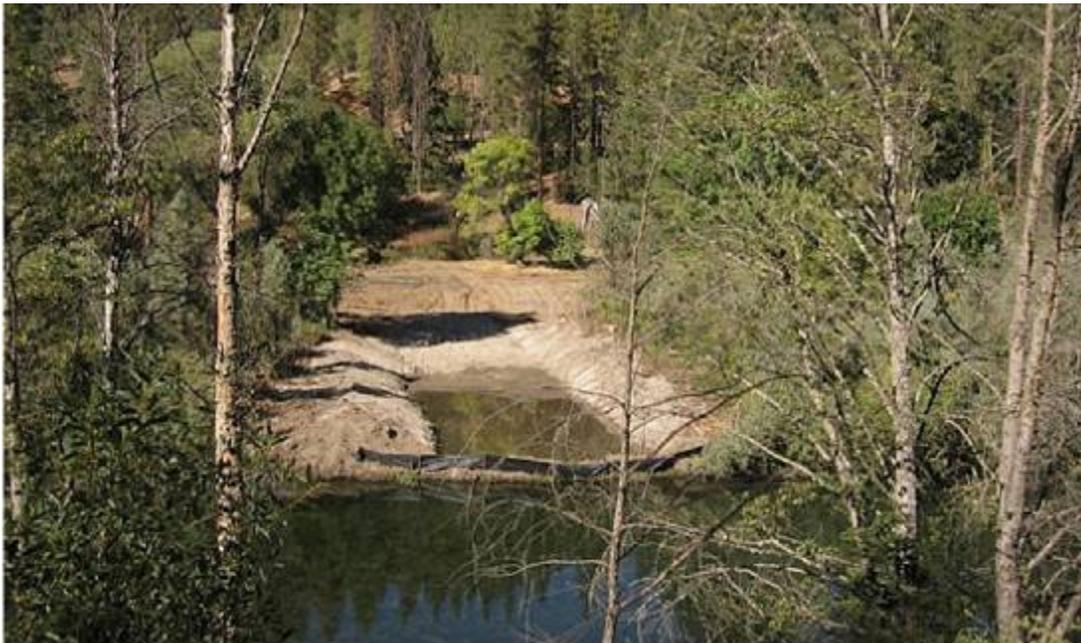
Berm notching at Vitzhum Gulch. Photo by the Trinity River Restoration Program

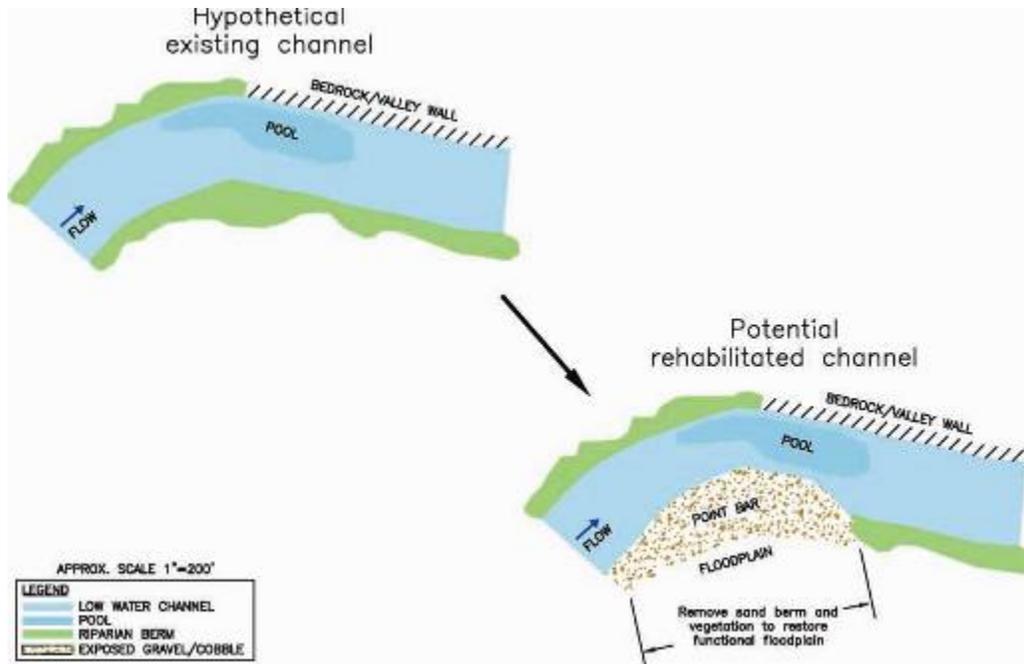
Figure 2. Intended treatment approach in the TRFEFR for “forced meander channel rehabilitations” as recommended at Vitzhum Gulch (Figure 8.16 in TRFEFR)

As described in Section 8.1 of the TRFEFR and illustrated in Figures 8.16 and 8.17 in the TRFEFR (Figures 2 and 3), channel rehabilitation at the Vitzhum Gulch site would have removed the sand berm and vegetation, restored point bars, added coarse sediment, restored a functional floodplain on the inside of the bend, and revegetated constructed floodplains with native riparian vegetation; the result expected from these actions would be substantial, long-term improvements to fish production. As shown in Figure 4, the TRRP implemented a berm notching design at the Vitzhum Gulch site, despite strong objection from the Fisheries Department, USFWS, and the Bureau of Reclamation Value Engineering Study, that deviates from the design approach dictated in the TRFEFR and ROD. The berm notching design does not remove most of the riparian berm, nor enable the river to resize itself and create complex channel morphology, thus represents a “pin prick” in restoring habitat rather than the overhaul intended in the TRFEFR and ROD. If the entire berm would have been removed, the underlying floodplain would have also been restored as envisioned in the TRFEFR. Instead, large swaths of the riparian berm were left in place and the floodplain was not restored. This will likely prevent a complex channel morphology to form in this reach. Berm notching also precluded any riparian replanting that would have occurred on the upland areas of a restored floodplain, should one have been built, as outlined in the TRFEFR.. The TRRP does not have discretion to deviate from the channel rehabilitation approach developed in the TRFEFR and adopted by the ROD.

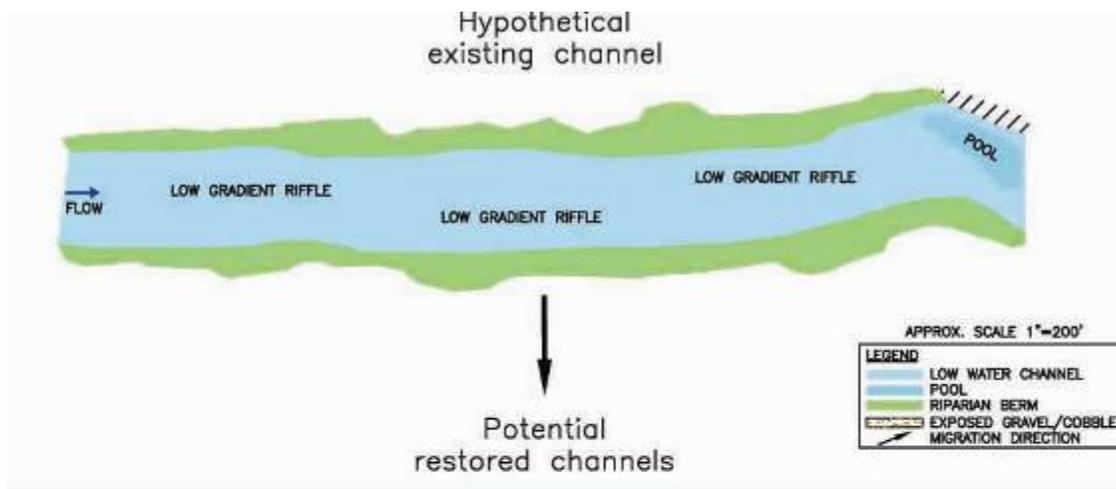
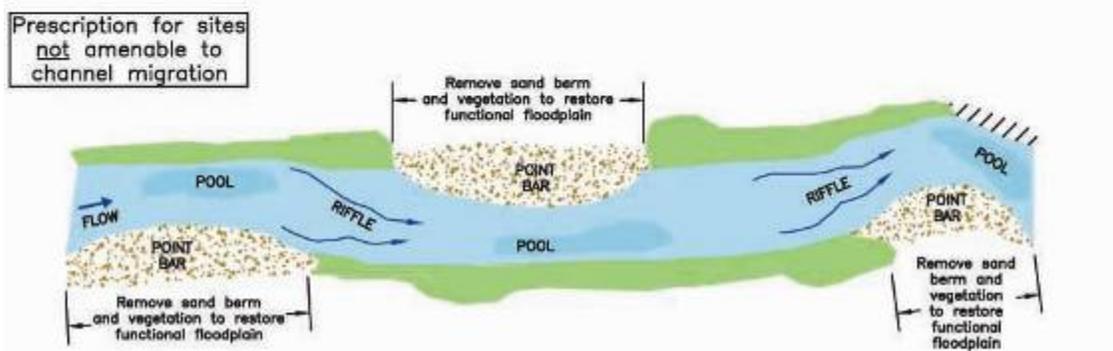
Figure 3. Intended treatment approach in the TRFEFR for “alternate bar channel rehabilitations” as recommended at Vitzhum Gulch (Figure 8.17 in TRFEFR). Given the large size of the Vitzhum Gulch site, both

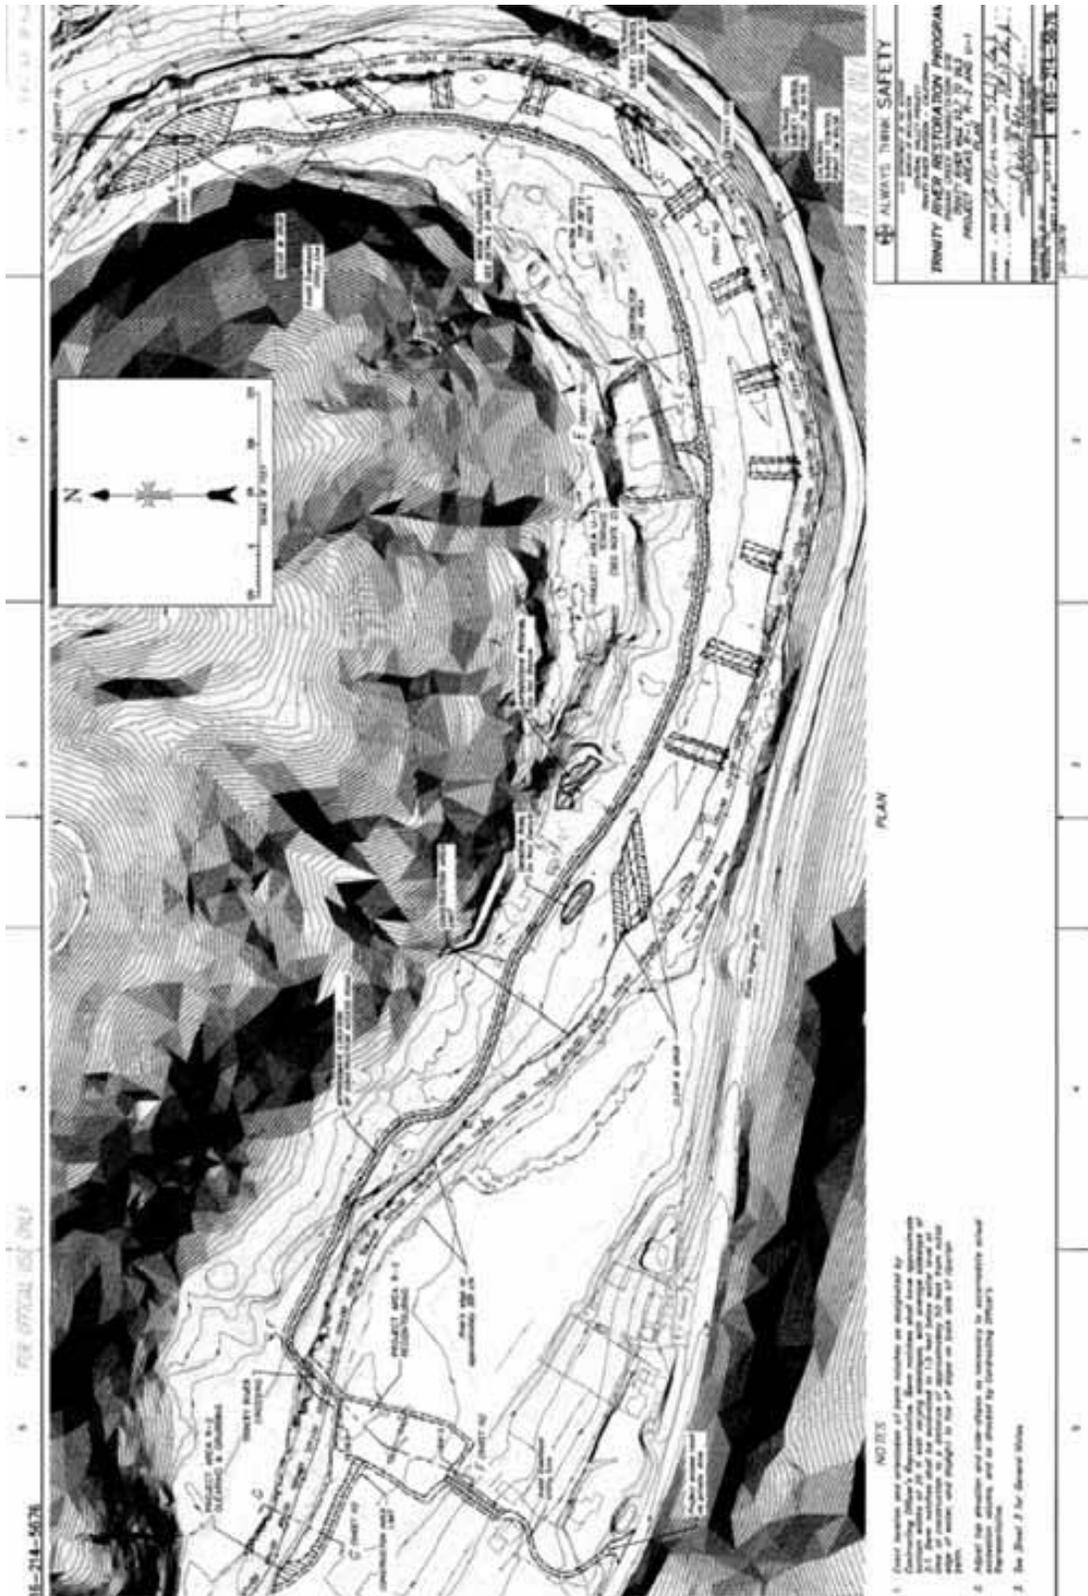
Figure 4. Rehabilitation design that was implemented at the Vitzhum Gulch bank rehabilitation site in fall 2007. Note “berm notching” approach rather than the complete berm removal dictated by the TRFEFR and ROD

There is been no evidence supplied to indicate berm notching at Vitzhum Gulch is a superior and more productive alternative to what was adopted in the ROD, let alone evidence that the experiment would even work at all. The TRRP should have the burden of proof responsibility to provide strong evidence on why the berm notching experiment at Vitzhum Gulch was likely to succeed, but did not do so.

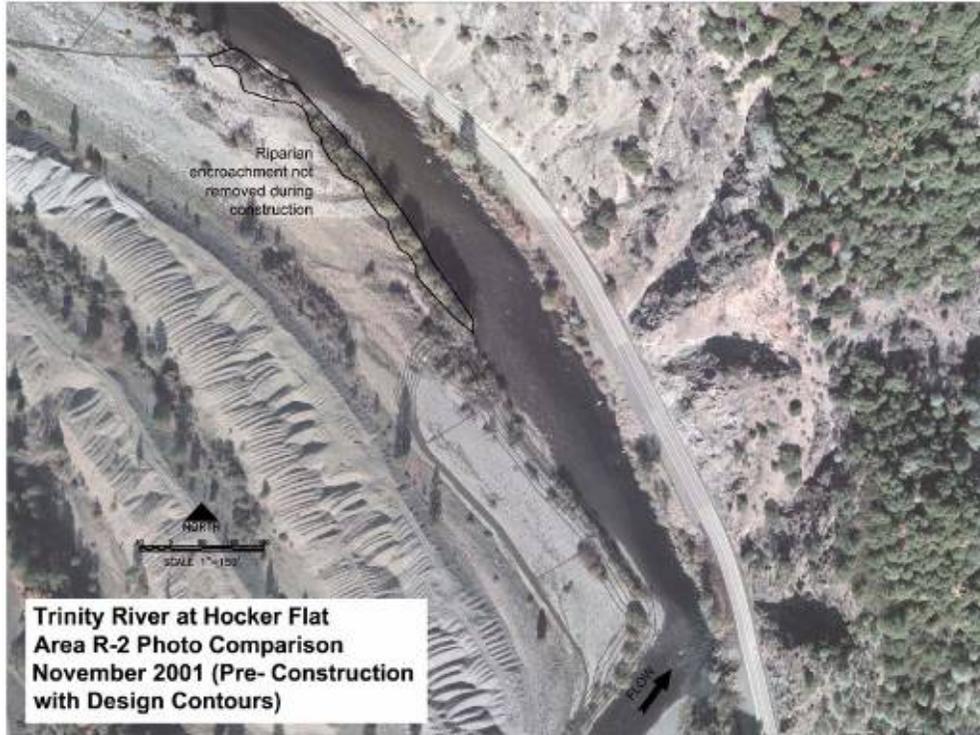
Figure 5. Trinity River at Hocker Flat, pre-construction riparian encroachment.

Implemented in September and October 2005, the Hocker Flat channel rehabilitation site was subjected to a 17,000 cfs peak flow on December 31, 2005. Photographic evidence of the upstream portion of the Hocker Flat shows that the riparian encroachment left standing after the mechanical restoration effort withstood the flood. The riparian berm and its community of trees and brush remained intact. As compared to Vitzhum Gulch, Hocker Flat has 1) larger peak flows (17,000 cfs versus 11,000 cfs), 2) a much larger supply of coarse sediment, and 3) a greater transport of large wood during peak flows, all of which should make Hocker Flat riparian vegetation more prone to removal by high water than at Vitzhum Gulch. Therefore, data from Hocker Flat predicts failure of the Vitzhum Gulch design (Figures 5 and 6).

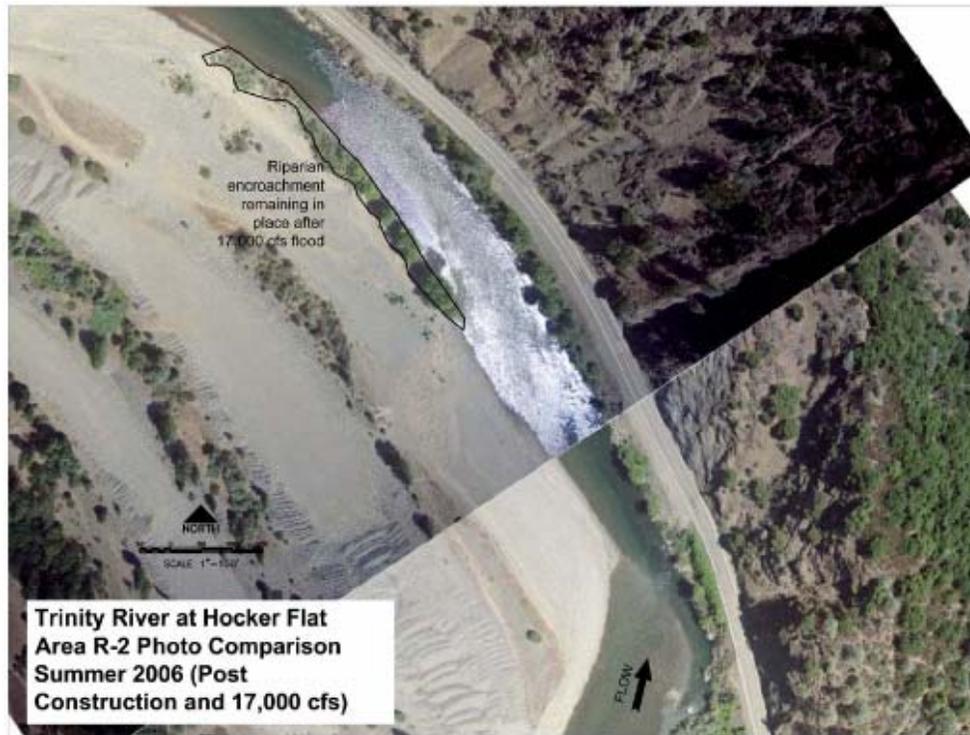
Figure 6. Trinity River at Hocker Flat, post-construction, and post 17,000 cfs flow. Note that riparian encroachment remains in place despite being fully exposed to high flows that are greater magnitude than maximum ROD releases (11,000 cfs).
